**DETAILED UXO
RISK ASSESSMENT**

Client: London Square
Project Ref: LOSQ14R
Site Name: Leegate, Lewisham
Report Ref: DRA-25-1870-Leegate,Lewisham-LOSQ14R
Revision: 0
Status: Final
Date: 28th May 2025

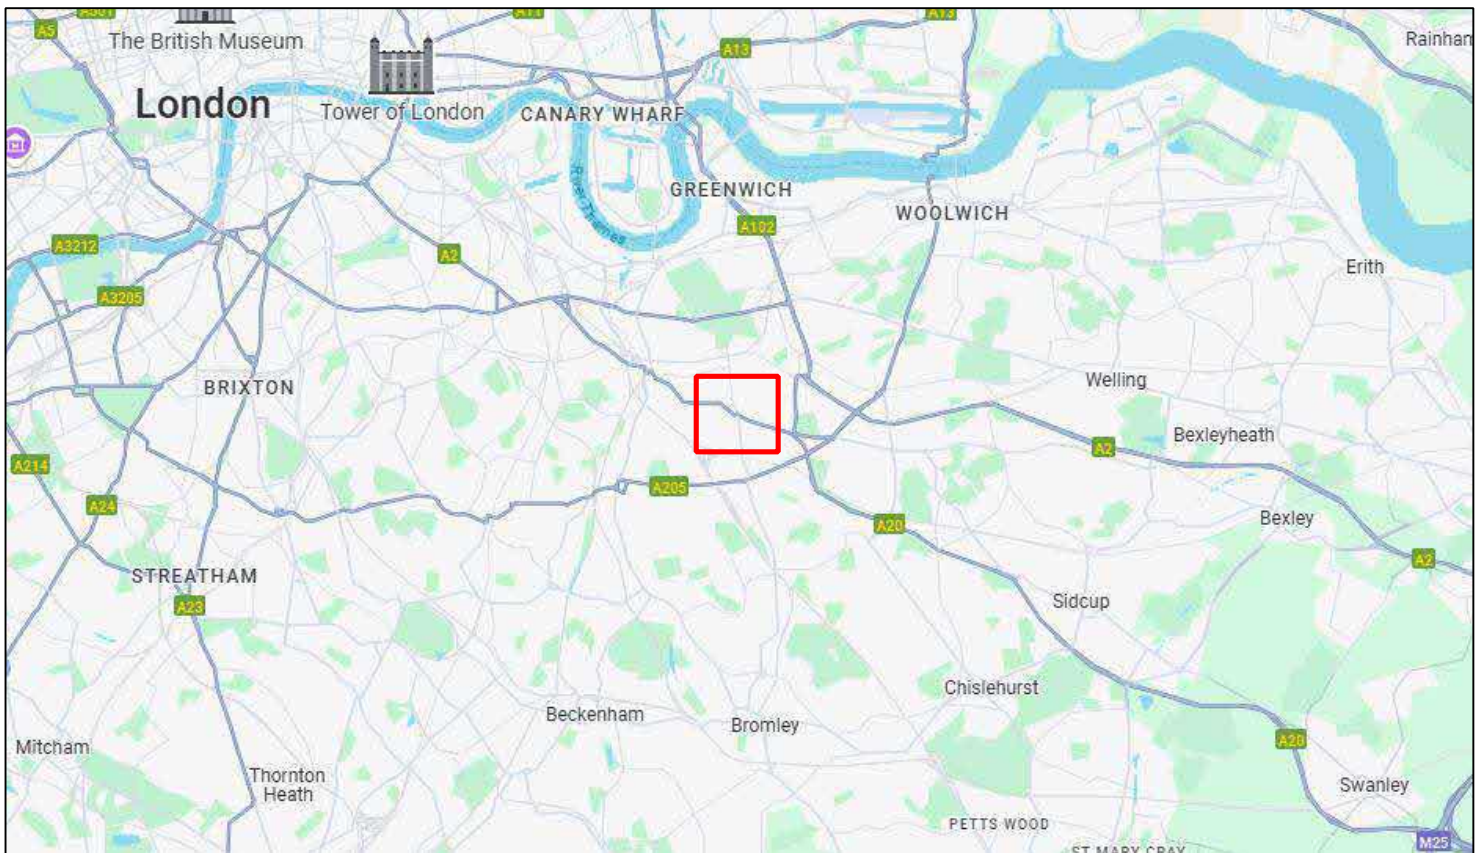
FIGURE: 1

Site Location Maps

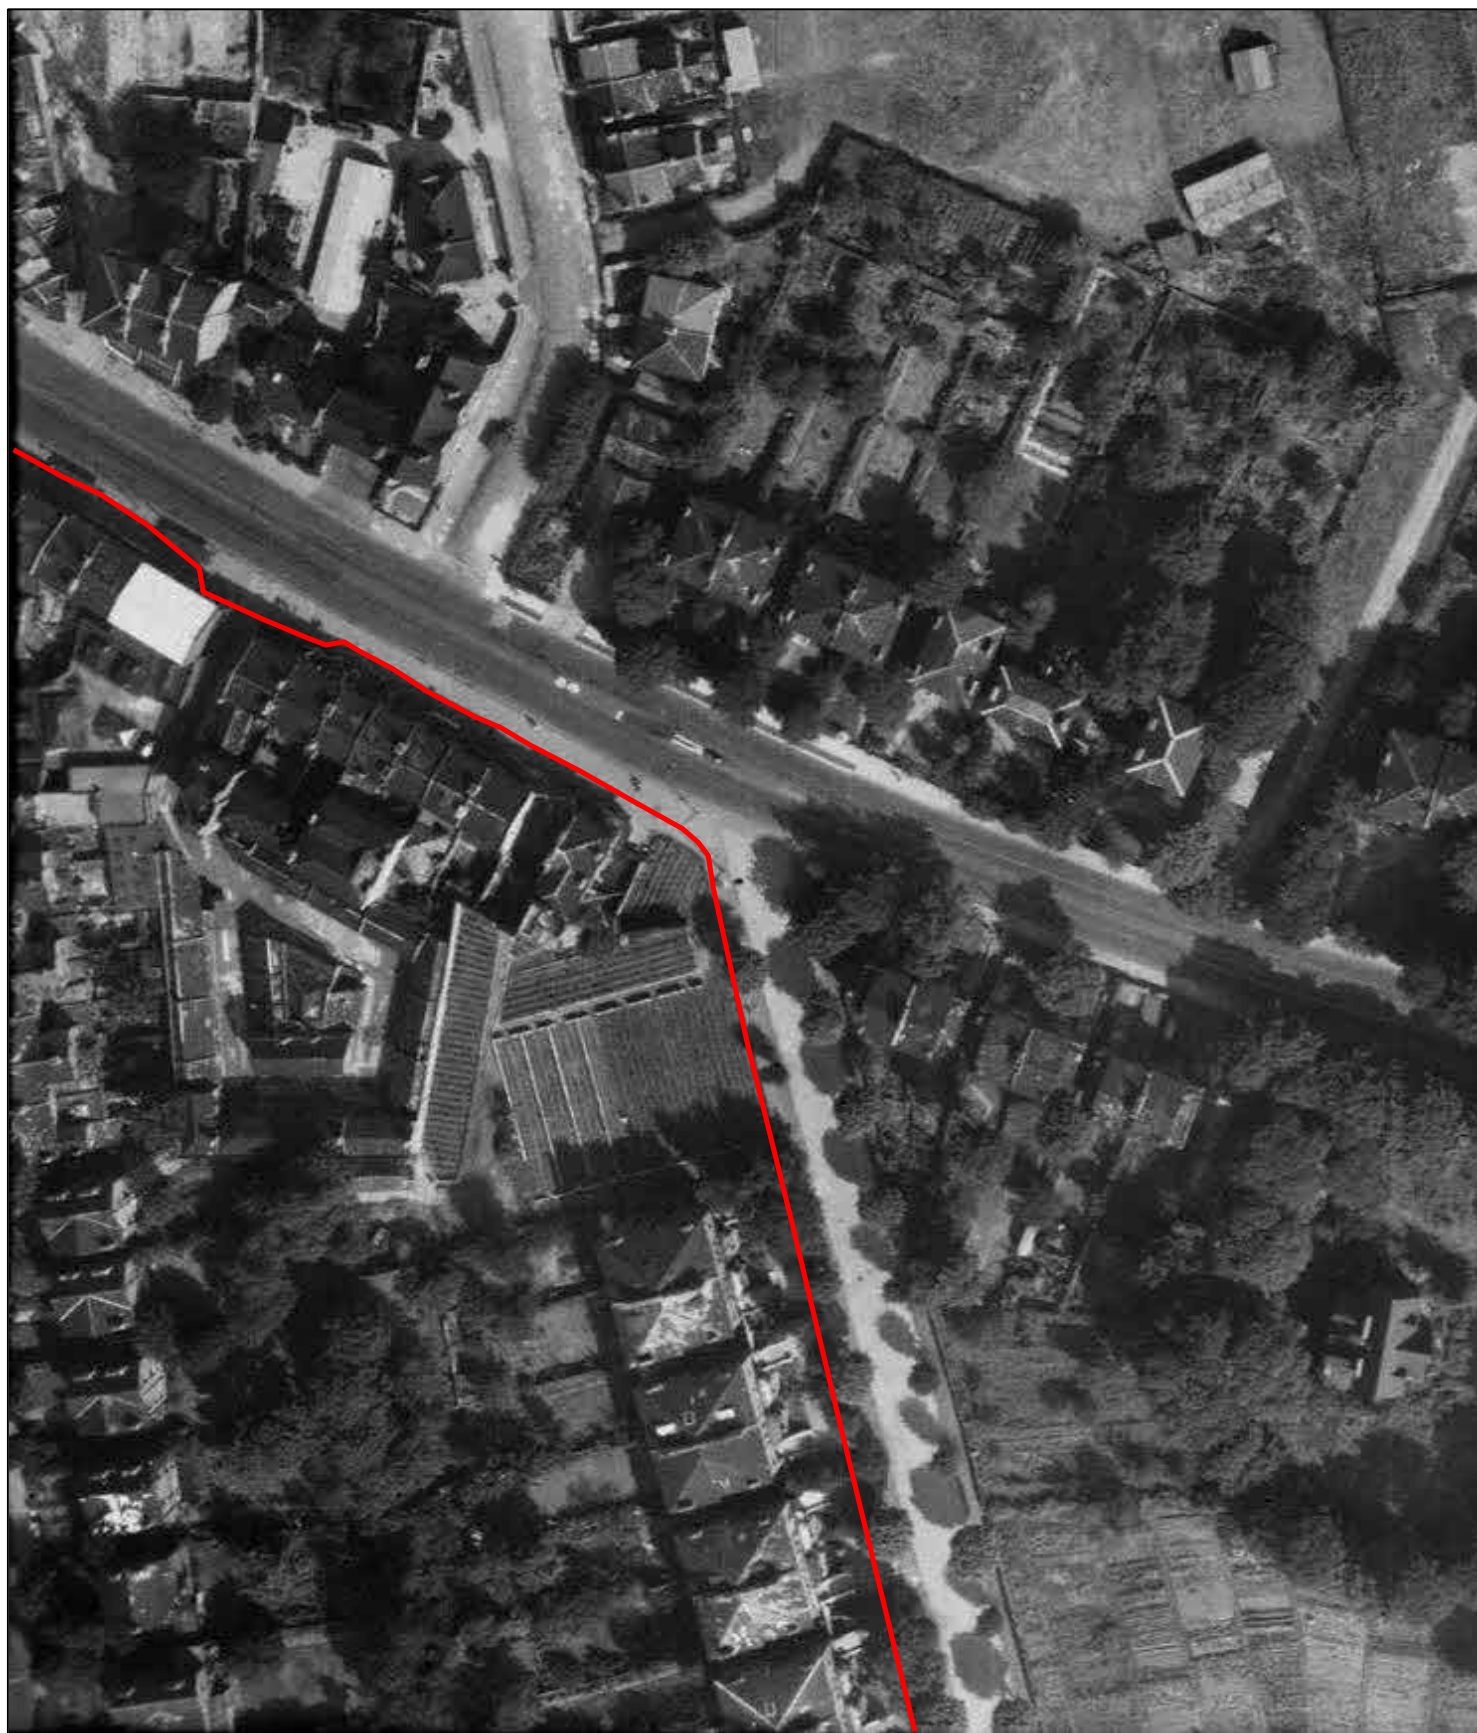
FIGURE: 5.1

Historical Aerial Photography – 26th August 1945

Period	Photo Date	Review
	26 th August 1945	<p>FIGURE 5.1 & 5.2: This image, displaying the north-western extent of the Site, was taken during the final year of WWII.</p> <p>The composition of this section of the Site is largely consistent with that identified in OS mapping. However, a single structure in the north-west of the Site has been visibly cleared.</p> <p>Various degrees of roofing repairs can also be seen to a number of the structures on Site. In the north, substantial repairs have been carried out, with the entire roof of one structure seemingly being replaced. In the east, minor tiling repairs are visible; this can be indicative of fire damage caused by incendiary bombing.</p>
Post-WWII	2 nd April 1946	<p>FIGURE 5.3 & 5.4: This vertical image, displaying the entire Site, was taken approximately a year after the end of WWII.</p> <p>Two additional instances of minor roofing repairs have been highlighted, approximately 30m south and 40m south-west of the Site. Furthermore, an area of structural clearance is visible approximately 20m west of the Site, on Burnt Ash Road. A large area of clearance, likely resulting from a V1 weapon strike (see FIGURE 8), is visible approximately 80m north of the Site.</p> <p>It should be noted that a majority of the structures on Site appear to have survived the war externally structurally intact. Associated garden areas are partially occupied by mature vegetation, obscuring the ground cover and preventing detailed analysis of these areas.</p>

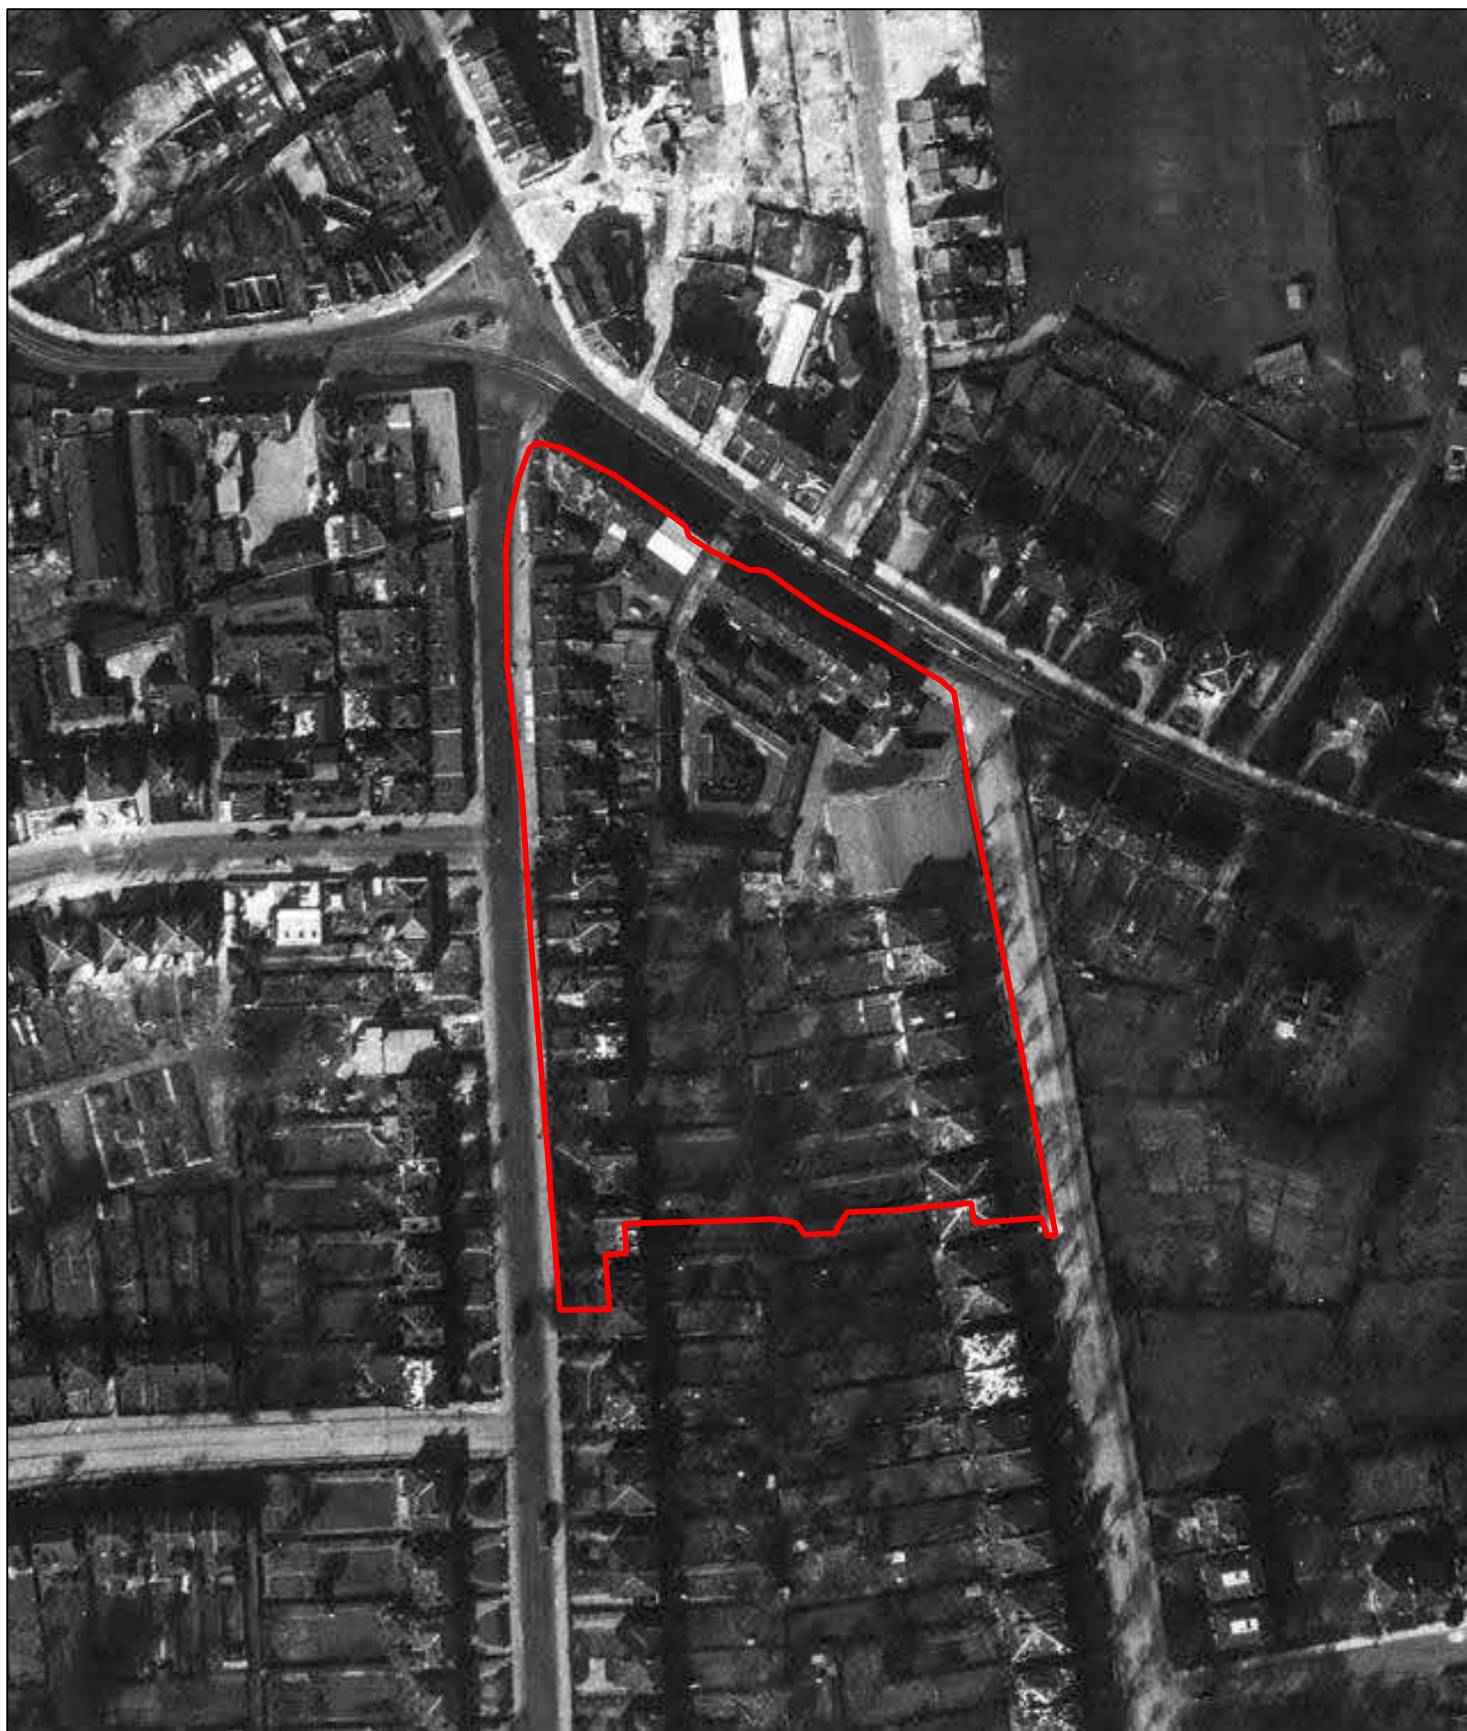
FIGURE: 5.3

Historical Aerial Photography – 2nd April 1946

One V1 strike is plotted within a close vicinity of the Site, approximately 100m to the north. This strike (occurring on 27th July 1944), caused significant damage and resulted in a large area of structural clearance, displayed at FIGURES 5.3 & 5.4. However, several blocks of buildings that survived the conflict intact will have shielded the Site from the 1,000kg HE blast.

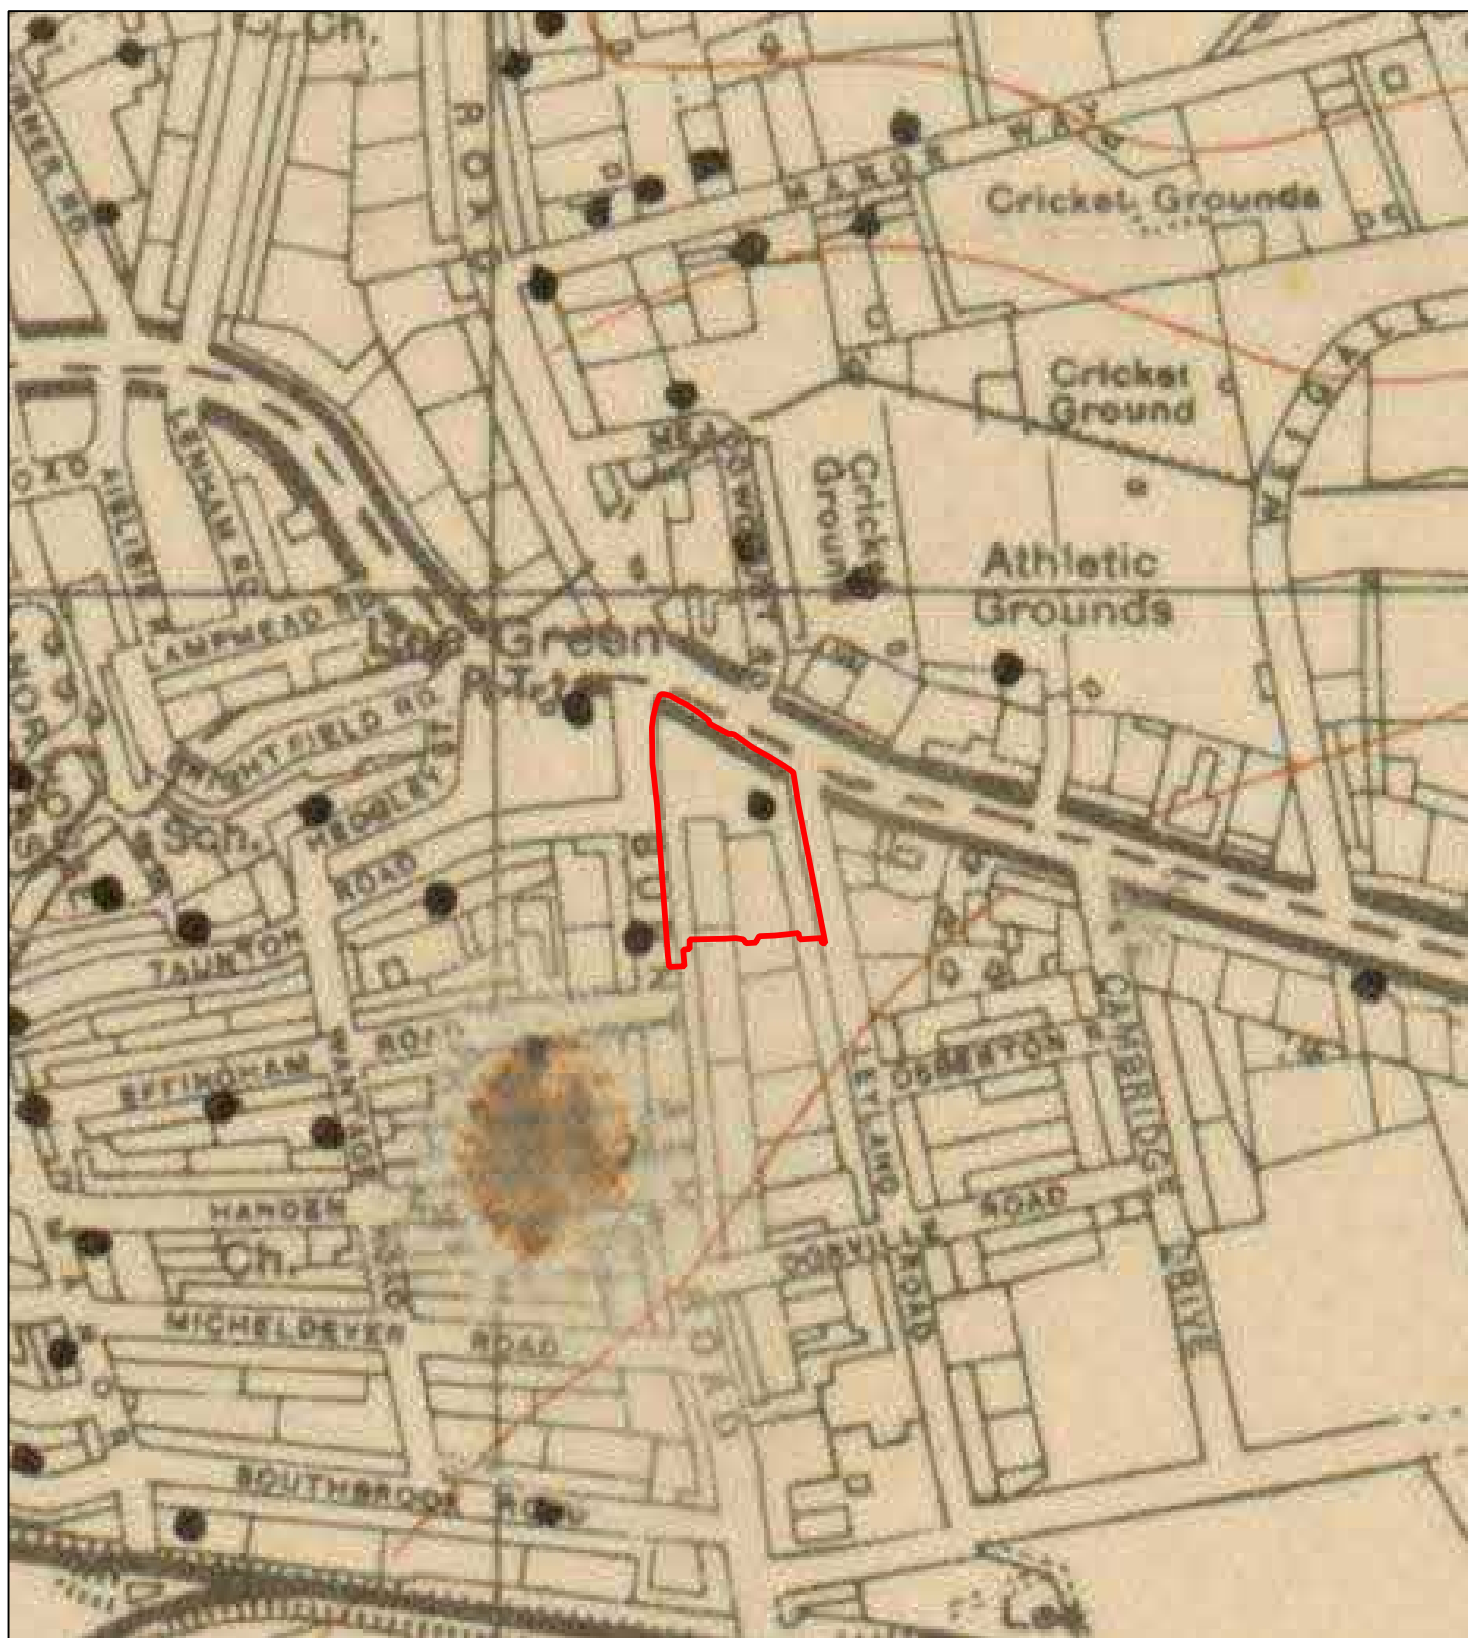
FIGURE: 6.1

Consolidated Bomb Census Mapping – Night Bombing up to 07/10/1940

● 'Iron' bomb

● Parachute Mine

Indeed, London bomb census mapping records 46 HE bomb strikes within an approximate 300m radius of the Site. One HE bomb is recorded in the north-east of the Site, with another directly along the southern Site boundary. In addition, two incendiary bomb 'showers' were also recorded within a 300m radius of the Site; one of these is partially recorded over the eastern extent of the Site. Furthermore, LCC bomb damage records structural clearance to a structure on Eltham Road in the north of the Site, with further structures in the south-western extent recorded as sustaining 'general blast damage- not structural'. The closest substantial damage within LCC mapping is approximately 20m west of the Site, where structures were 'damaged beyond repair'.

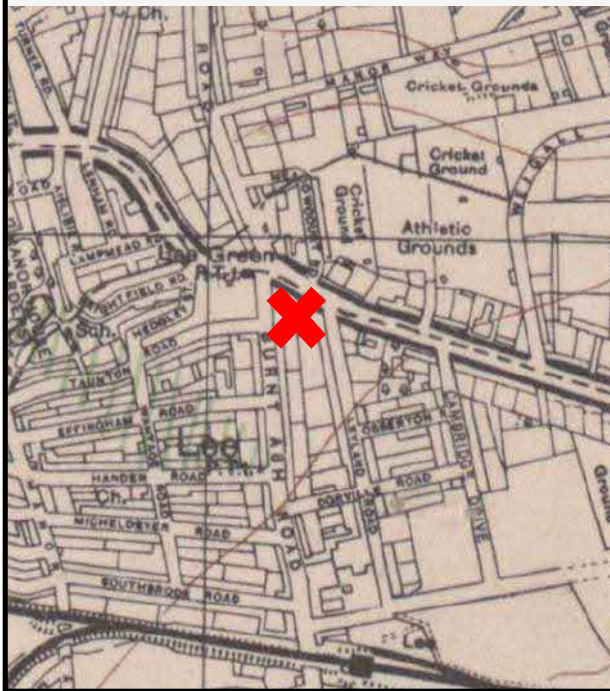
FIGURE: 6.4

18/11/1940 – 25/11/1940

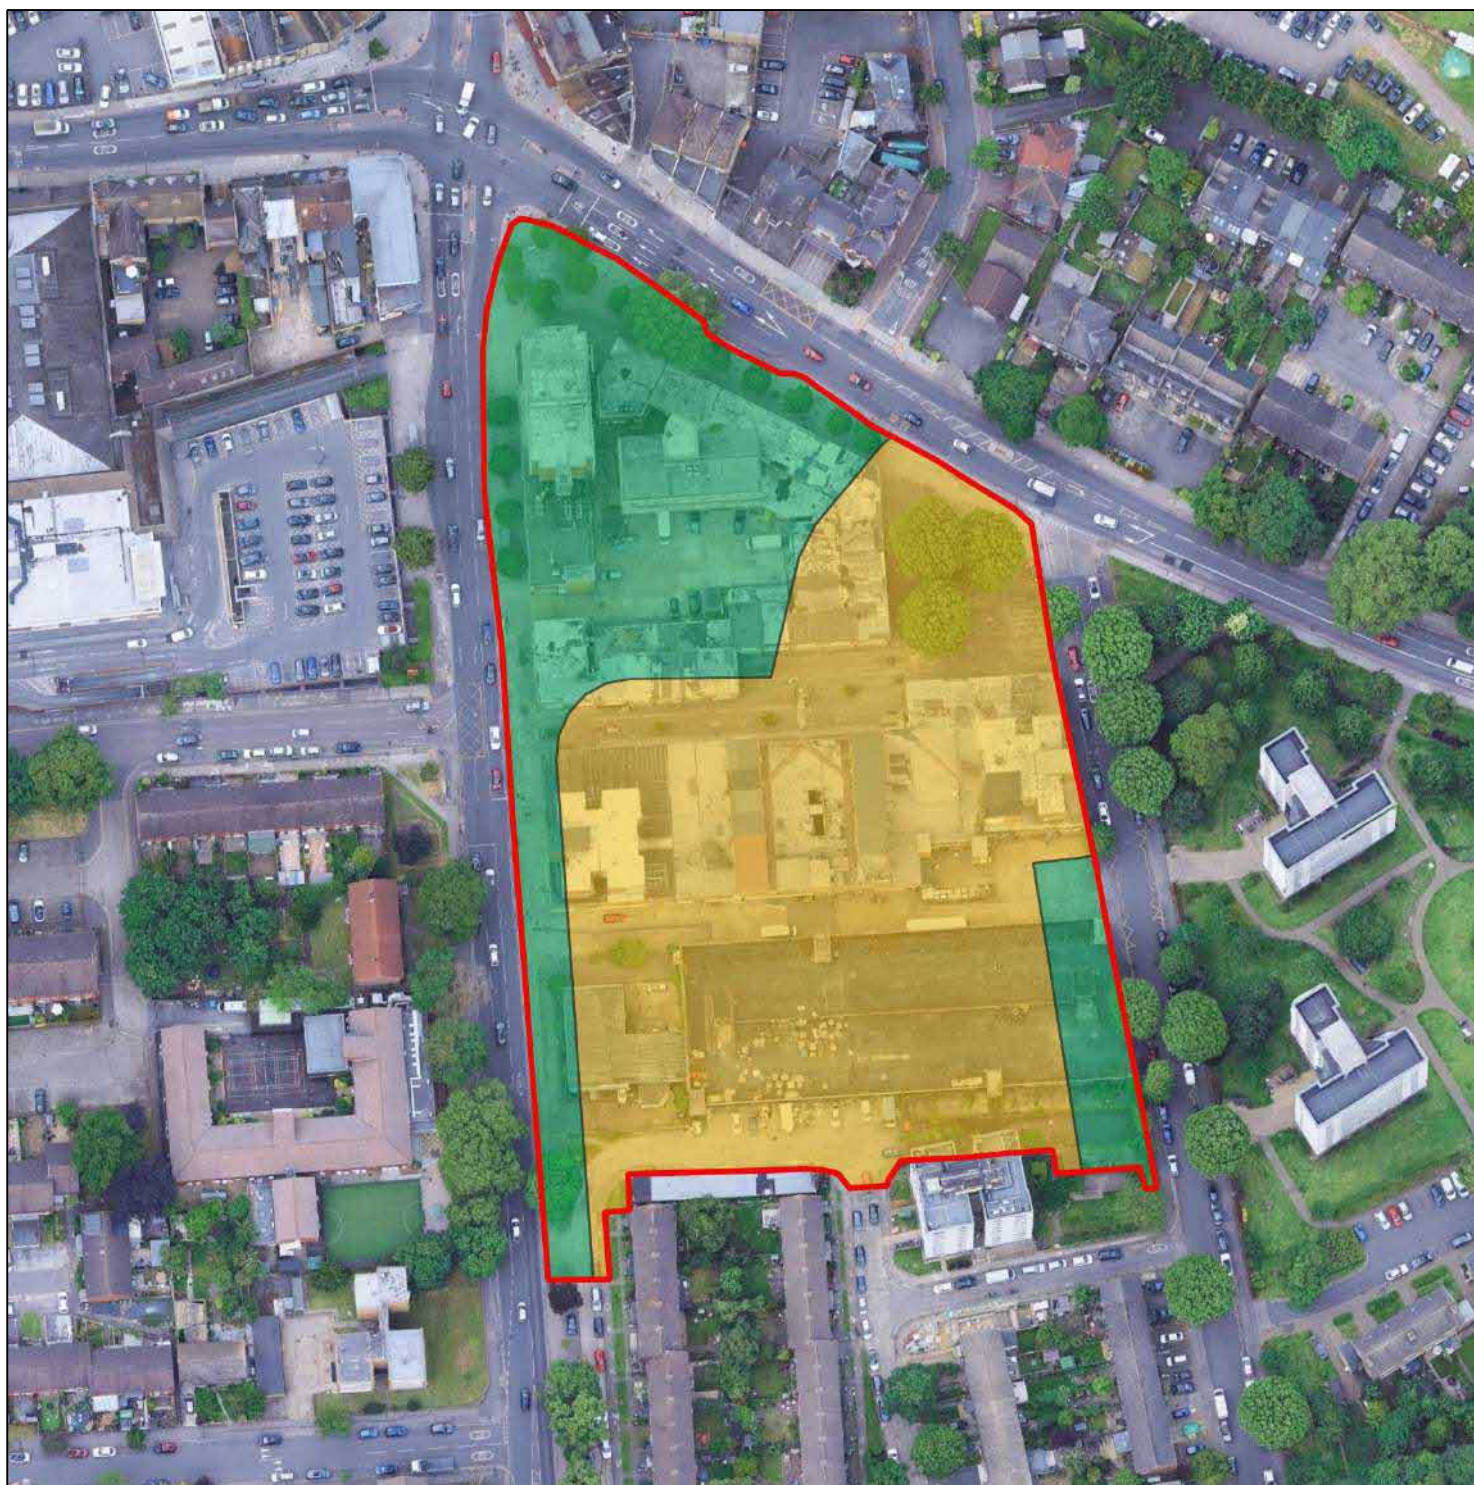
FIGURE: 9.2

Risk Map

LOW RISK: Low likelihood of German and British UXO remaining here.

MODERATE RISK: Elevated likelihood of German UXO remaining here.

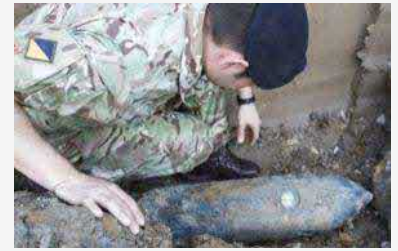
SC 50

Bomb Weight: 40-54kg (110-119lb)
 Explosive Weight: 25kg (55lb)
 Filling: TNT, Amatol or Trialen
 Charge/Weight Ratio: 46%
 Fuse Type: Electrical impact fuse or mechanical delayed action fuse
 Body Dimensions: 1,100mm length x 200mm diameter
 Appearance: Bomb body and tail painted grey/green with a yellow stripe on the tail unit. Steel construction.
 Variants: 8 x variants. Additional fittings: Kopfring nose for limited penetration and Stabbo nose for dive-bombing.

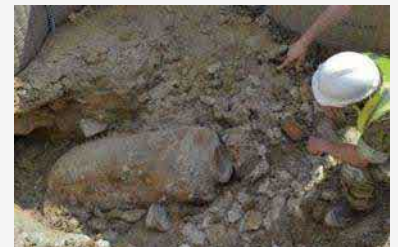
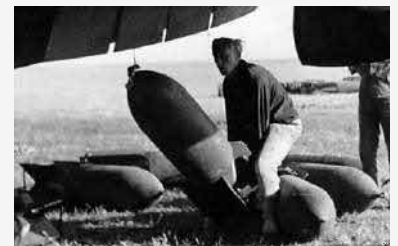
SC 250

Bomb Weight: 245-256kg (540-564lb)
 Explosive Weight: 125-130kg (276-287lb)
 Filling: TNT, Amatol and Trialen mix
 Charge/Weight Ratio: 44%
 Fuse Type: 1 or 2 electrical impact fuse(s) or mechanical delayed action fuse(s)
 Body Dimensions: 1,173mm length x 368mm diameter
 Appearance: Bomb body and tail painted grey/green with a yellow stripe on the tail unit. Steel construction.
 Variants: 8 x variants. Kopfring nose for limited penetration. Stabbo nose for dive-bombing.

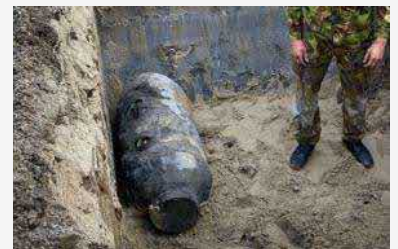
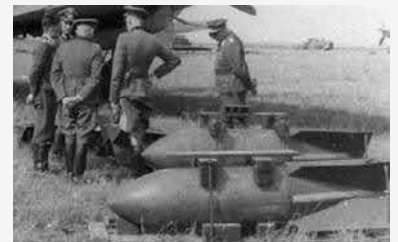
SC 500

Bomb Weight: 480-520kg (1,058-1,146lb)
 Explosive Weight: 220kg (485lb)
 Filling: TNT, Amatol and Trialen mix
 Charge/Weight Ratio: 44%
 Fuse Type: 2 electrical impact fuses or mechanical delayed action fuses
 Body Dimensions: 1,423mm length x 470mm diameter
 Appearance: Bomb body and tail painted grey/green or buff with a yellow stripe on the tail unit. Steel construction.
 Variants: 3 x variants. Kopfring nose for limited penetration.

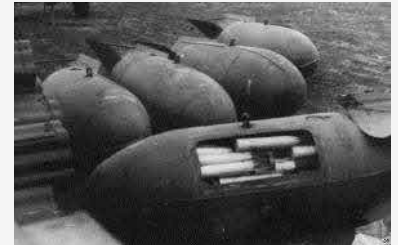
B-1E Sub-Munition

Bomb Weight:	1-1.3kg (2.2-2.87lb)
Incendiary Weight:	680g (1.4lb)
Filling:	Thermite
Fuse Type:	Simple impact fuse
Body Dimensions:	247mm length x 50mm diameter
Appearance:	Grey body and dark green painted tail unit. Magnesium alloy case.
Operation:	Small percussion charge ignites Thermite (>1,000°C burn).
Variants:	Most common variant: B 2EZ (2kg) included a small HE charge
Remarks:	Drop containers varied in size. The smallest cluster bomb held 36 x B-1Es and the largest 620 x B-1Es.

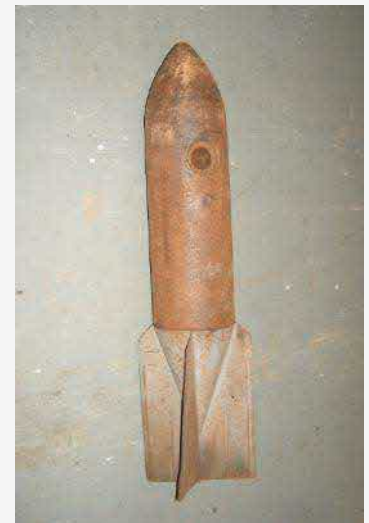
Brand C50

Bomb Weight:	41kg (90.4lb)
Incendiary Weight:	13kg (30lb)
Filling:	Main fill (86% Benzine, 10% Rubber) plus 4% Phosphorus in glass bottles
Fuse Type:	1 x electrical impact fuse
Bomb Dimensions:	762mm length x 203mm diameter
Appearance:	bomb body and tail painted grey or green with the rear of the bomb painted red and a red band around the centre of the body.
Variants:	C 50 B: 77% White Phos fill C 250 A: 87.7% Petroleum, 11.7% Polystyrene, 0.5% White Phos (185kg version)

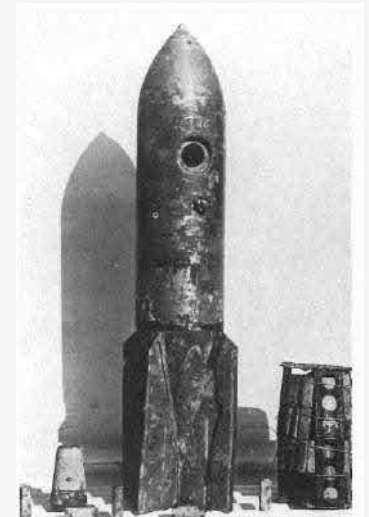
Spreng-Brand C50 - Fire Pot

Bomb Weight:	34kg (75lb)
Explosive Weight:	9kg (20lb)
Filling:	TNT burster charge, 6 x Thermite containers (fire pots) and 67 x small triangular incendiary elements.
Fuse Type:	1 x electrical impact fuses or aerial burst fuse
Bomb Dimensions:	711mm length x 203mm diameter
Appearance:	Bomb body and tail painted grey/green or pale blue with red base plug and red or green incendiary markings. Steel construction.
Operation:	A charge blows off the base plate, firing a plume of incendiary mixture 100 yds. Approx 1 second later the HE charge detonates.

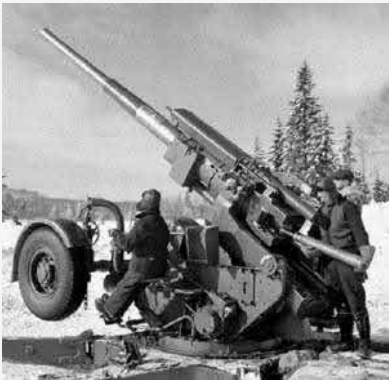
HAA Battery - 3.7" QF Shell

Shell Weight: 12.7kg
Shell Dimensions: 94mm x 438mm
Fill Weight: 1.1kg
Fill Type: TNT
Fuse Type: Mechanical Time Delay fuse
Appearance: Grey body, copper driving bands, brass neck
Rate of Fire: 10 - 20 rpm
Ceiling: 9,000 - 18,000m
Variants: HE or shrapnel shells.
Note, the 4.5" gun was also used in an HAA role throughout the UK.

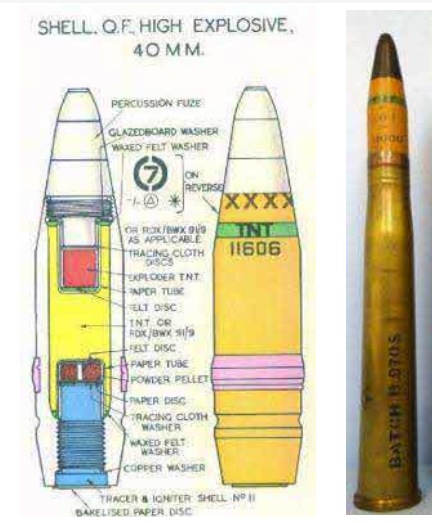
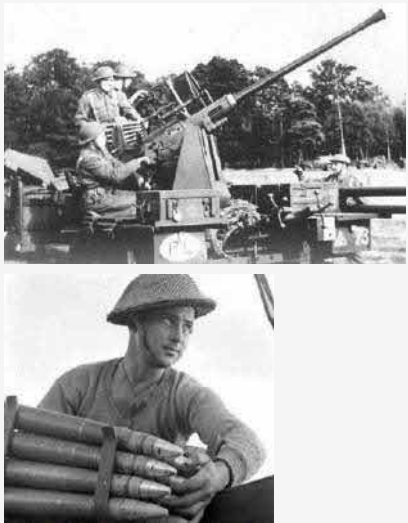
LAA Battery - 40mm Bofors Shell

Shell Weight: 0.84kg
Shell Dimensions: 40mm x 180mm
Fill Weight: 70g
Fill Type: TNT
Fuse Type: Impact fuse
Appearance: Grey body, copper driving bands, brass neck
Rate of Fire: 120 rpm
Ceiling: 7,000m
Variants: HE or AP shells. Both with rear tracer compartment

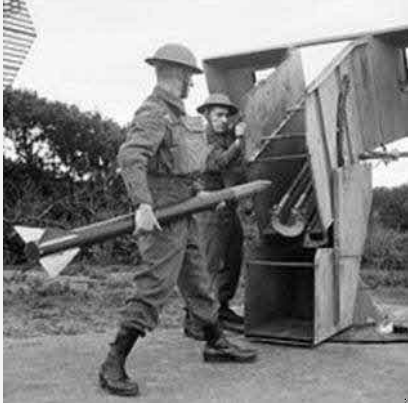
Z Battery - 3" U.P Rocket

Rocket Weight: 24.5kg
Warhead Weight: 1.94kg
Filling: TNT warhead. Black Powder solid fuel rocket motor.
Fuse Type: Mechanical Time Delay fuse
Rocket Dimensions: 1,930mm x 76mm
Ceiling: 6,770m
Operation: Fired from single, tandem and (later) 36 x rail launchers (Z Batteries). Limited use throughout the UK.
